Manhole Inspection Summary

Manhole # S15KK1001MH

Insp Date: **12/5/06 2:21 PM**

Location Address: **EDGECOMBE CIR**

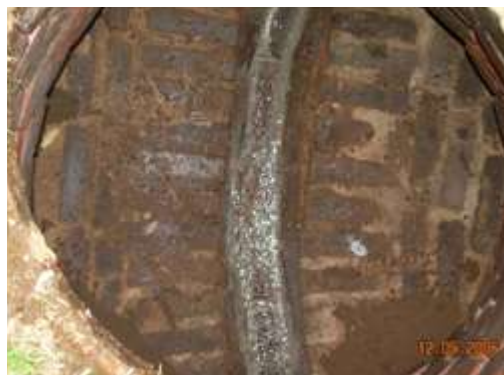
Top View

☐ Parged ☒ **Debris** (not Condition related)

Bench debris.

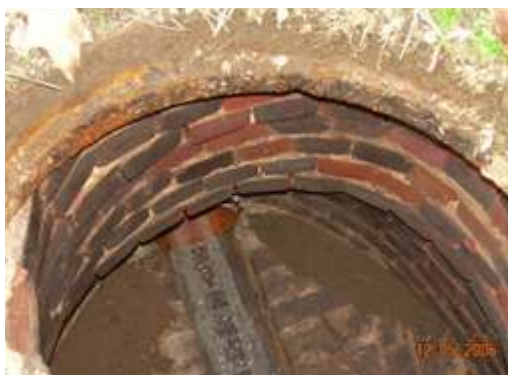
Defect

☒ **Leaks**

Frame leaks.

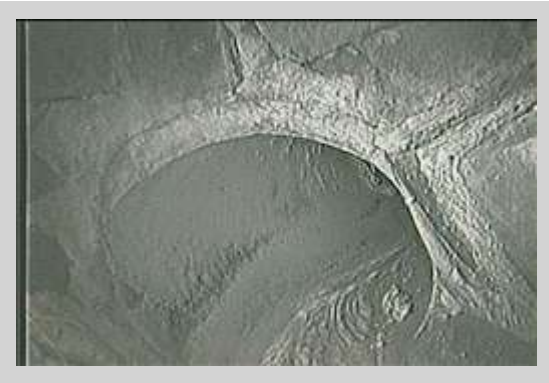
6 in. Circular Gravity Sewer Pipe Out @ 12 O'Clock

Infiltration: **Evidence** Pipe Seal Cond: **Cracked**

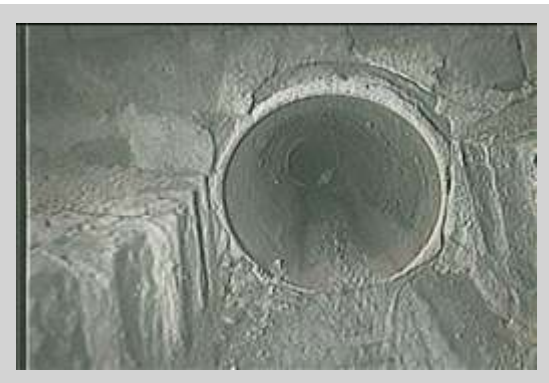
6 in. Circular Gravity Sewer Pipe In @ 5 O'Clock

Infiltration: **Evidence** Pipe Seal Cond: **Unknown**
